SUSQUEHANNA RIVER BASIN
BLACK MOSHANNON CREEK, CENTRE COUNTY

KEPHART DAM
NDS I.D. No. PA-00447
PENNDER I.D. No. 14-89

PHASE I INSPECTION REPORT
NATIONAL DAM INSPECTION PROGRAM

MARCH 1979

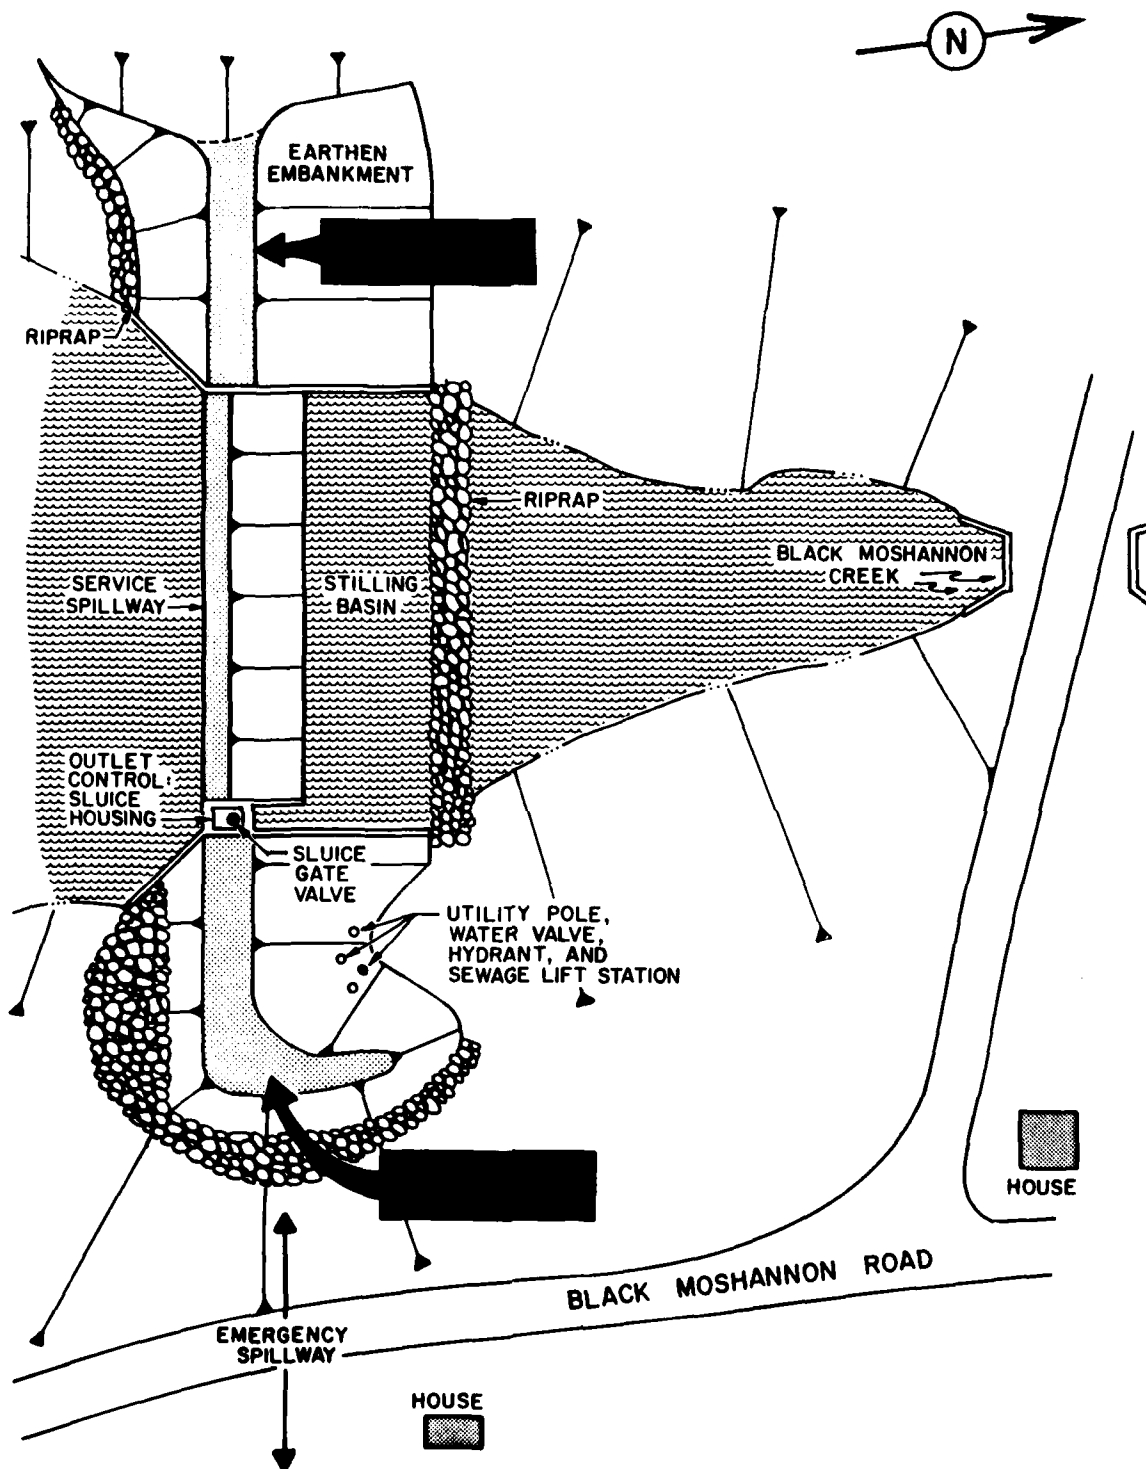
FIGURE 1 - KEPHART DAM
GENERAL PLAN
FIELD INSPECTION NOTES

Both the upstream and downstream faces of the dam are covered with crown vetch. Minor settlement was noted on the dam crest along both sides of the spillway. The maximum settlement noted at the time of inspection was approximately 0.6 feet below the designed crest elevation of 1874.0 feet.

Observations made during the visual inspection indicate that the overall condition of the facility is good. Minor settlement of the embankment crest was noted. The crest should be surveyed and low spots filled in.
